U.S. ENVIRONMENTAL PROTECTION AGENCY POLLUTION/SITUATION REPORT 2015 Gold King Mine Release SITREP

Subject: SITREP #4

Gold King Mine Release

Date: 08/12/2015

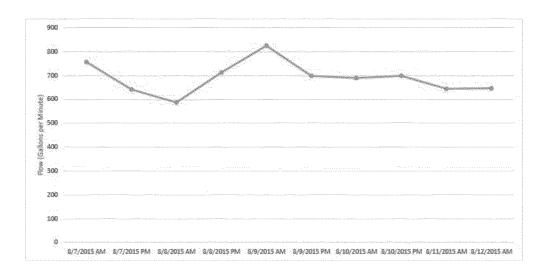
The EPA continues to operate four treatment and sedimentation ponds at the mine site which are treating water by lowering acidity levels and removing dissolved metals. Flow from the mine through the morning of 8/12/2015 is shown in the following chart.

Treated water from the last treatment pond is discharging into Cement Creek at levels cleaner (higher pH and lower levels of metals) than pre-event, background conditions in the creek. Over the next several days, the EPA will make upgrades to the system to ensure its continued operation. Flow data out of the mine is being collected manually two times per day. Water quality data is being collected at the influent and effluent of the treatment
